An armillary
sundial
supported by
an Atlas figure

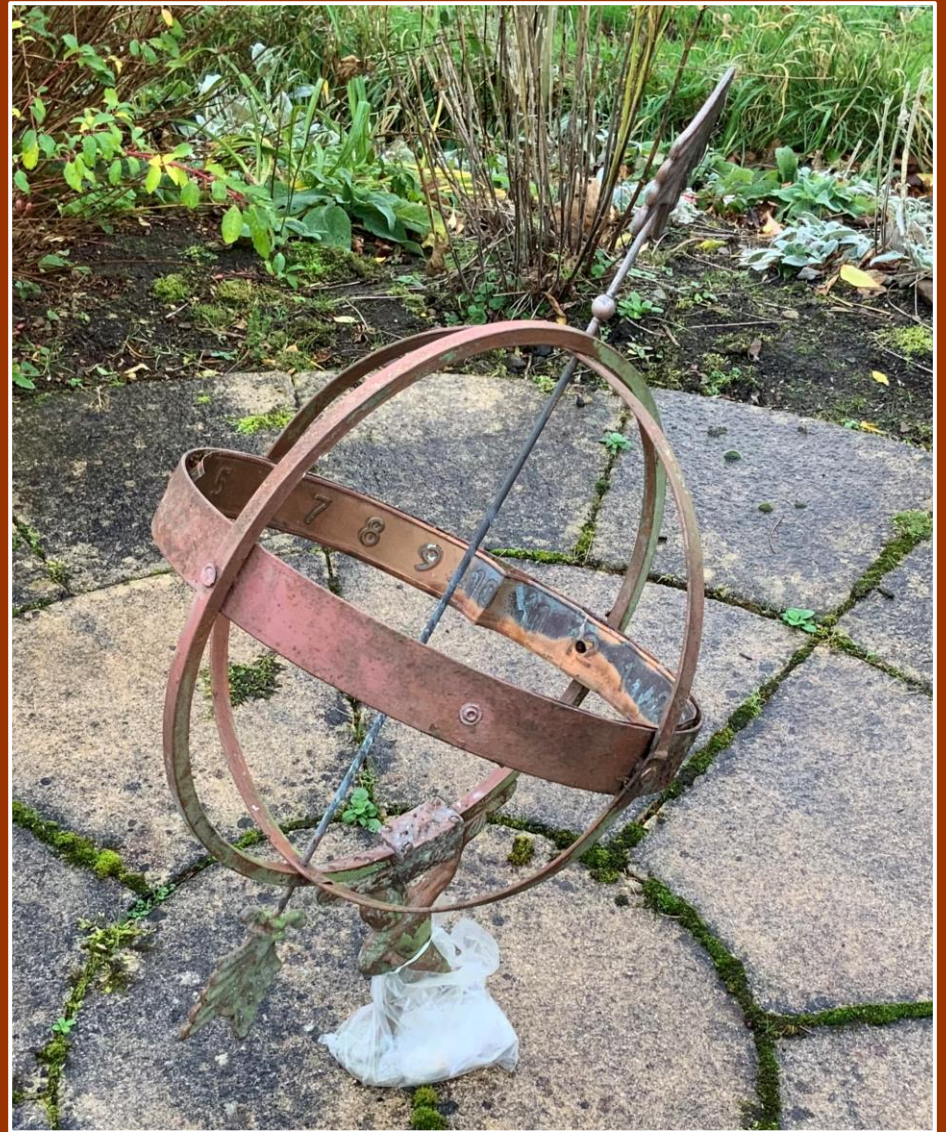
Before restoration the
sundial was in poor
condition

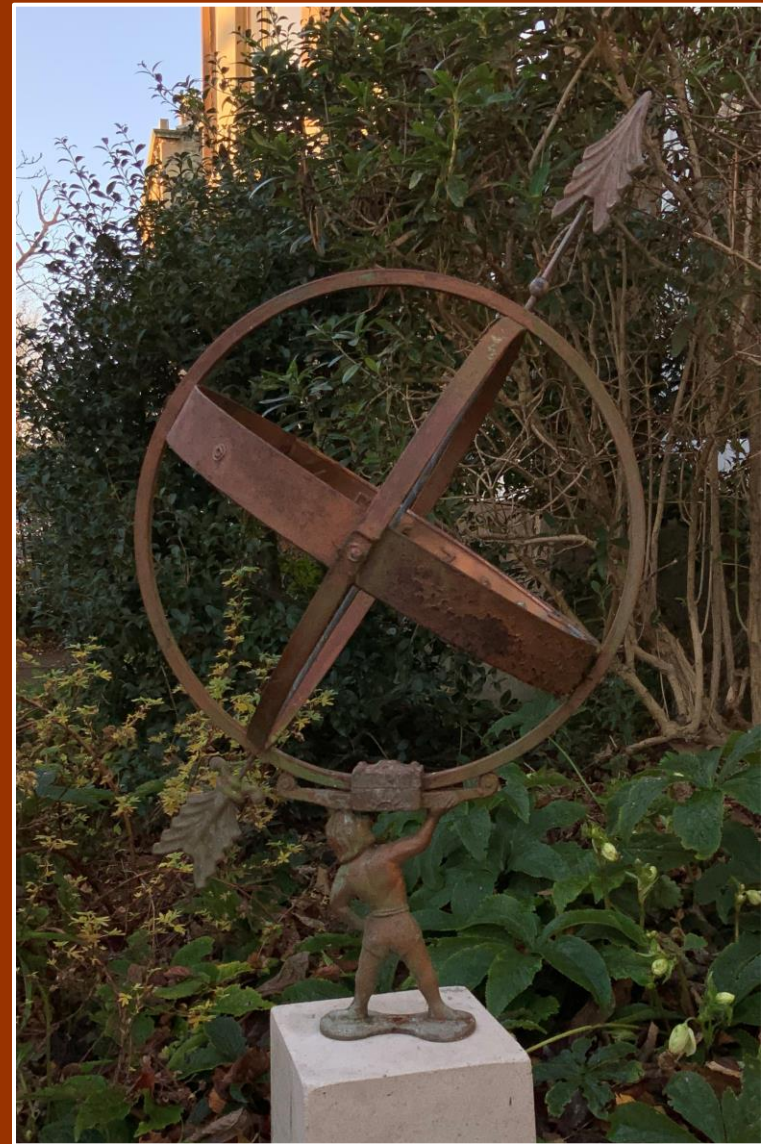
The general appearance was rusty metal

All the sundial parts were discoloured, and the rivets that held the frame together were loose or missing

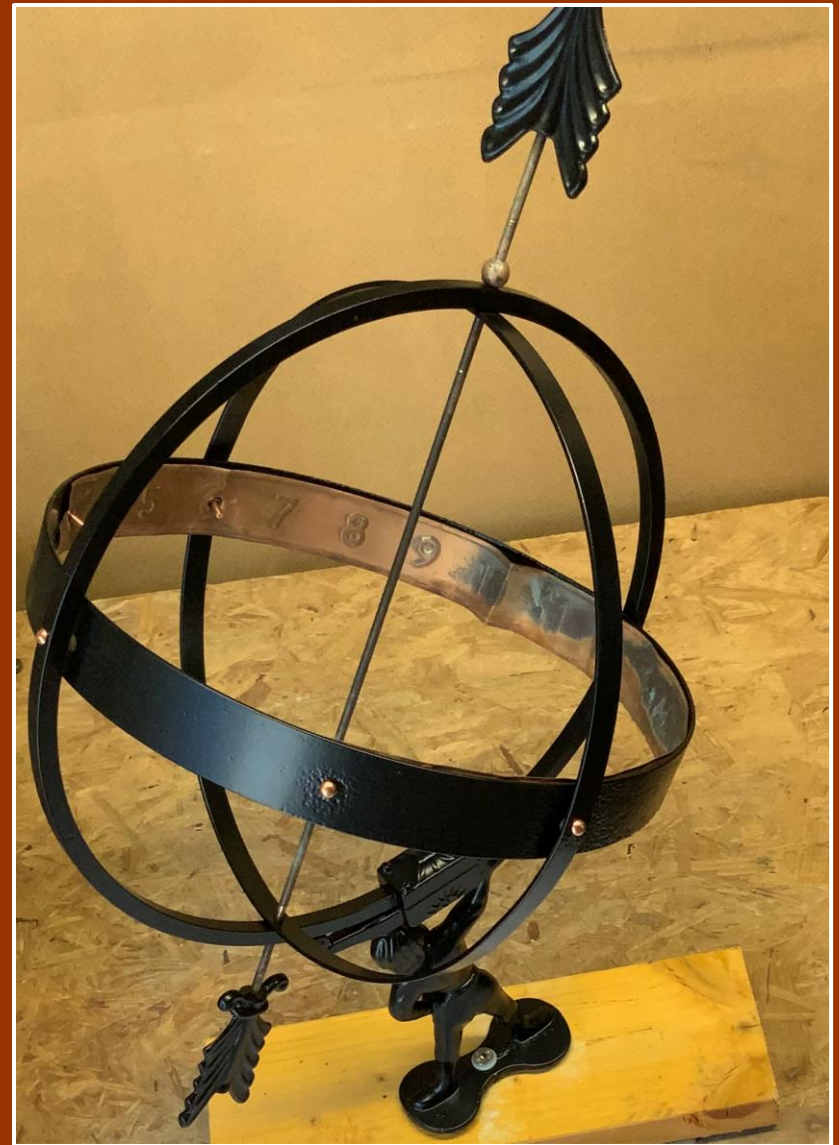
A trial rebuild
with temporary
rivets

The main metal parts
have been stripped,
primed and repainted
black. The copper
band and arrow shaft
still need treatment.

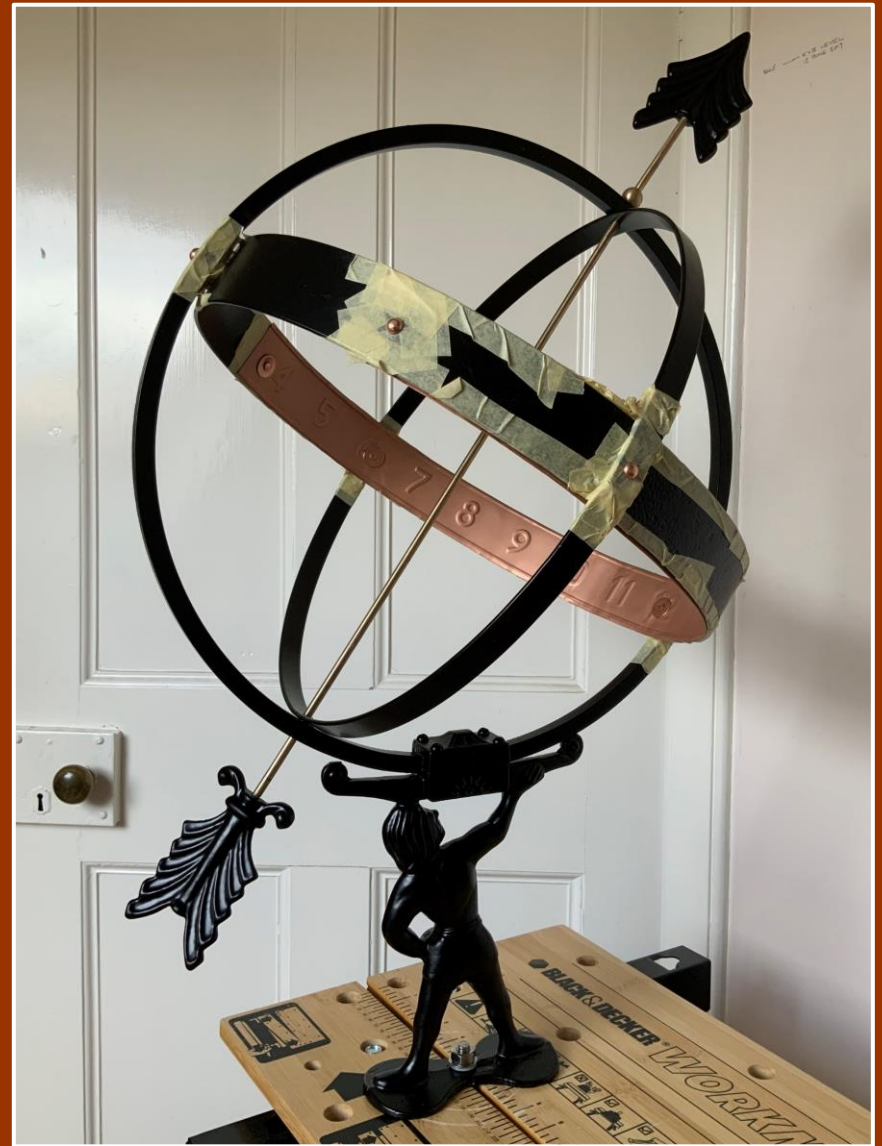
A complete
rebuild with
new rivets

The copper band has
been straightened
and its fixing holes
adjusted. Copper and
brass parts have been
cleaned and waxed.

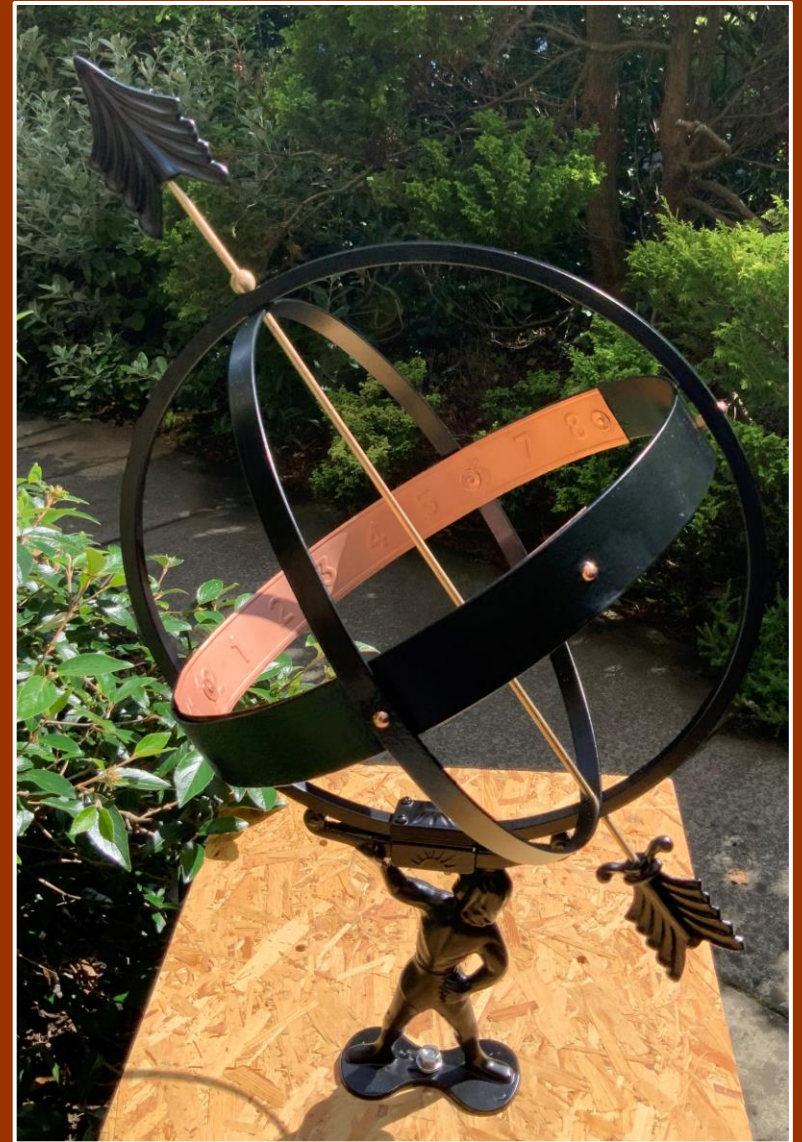
The Atlas
armillary
sundial as it
appeared in
sunshine after
restoration
